LESSONS LEARNED FROM NEPAL EARTHQUAKE (M 7.8): DAMAGE BEHAVIOUR OF BUILDINGS IN BANGLADESH

M.R. Awall¹, M.A. Rahman^{*2}, K.M.S. Uddin³

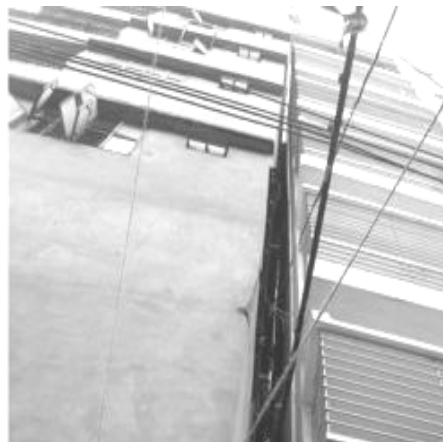
In Bongsal, Dhaka a six storied building was tilted due to this earthquake as shown in Fig. 4 (“Losses of Earthquake”, 2015). Due to vibration of earthquake differential settlement occurred in the soil layer below the structure. As a result the building was tilted.

Figure 4: Tilted Building in Bongsal (“Losses of Earthquake”, 2015)

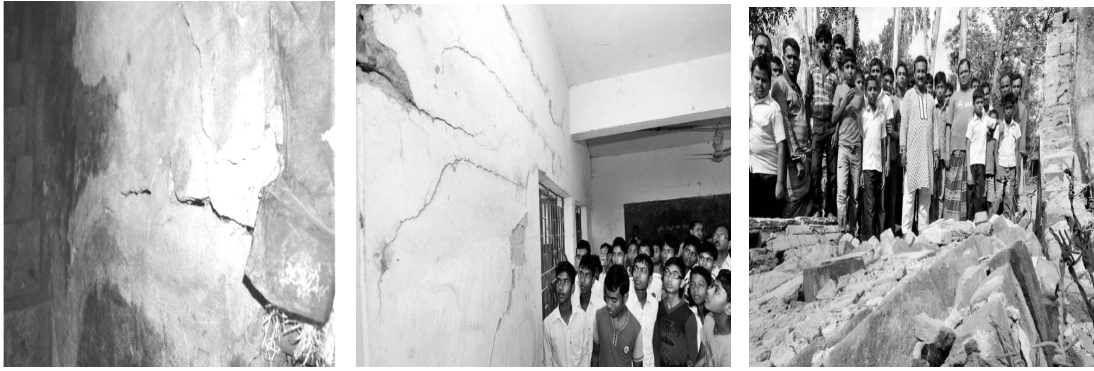
In Dhaka another building was affected by earthquake. Crack was formed in the wall of staircase of this Building. In Bogura wall of a primary school was cracked and boundary wall of a hospital was collapsed as shown in Fig. 5 (“Losses of Earthquake”, 2015). The primary cause of these types of failure is the use of solid brick. Solid brick walls are vulnerable to earthquake. They can be supported only by sand and cement mortar. In solid brick wall there is no way to provide rebar in horizontal or vertical direction for stiffening it. So due to heavy shake of earthquake it cracks and collapses. Beside this due to use of solid bricks the total weight of building increases which adversely affect the earthquake resisting capacity of the building structure.

Figure 5: Cracked Staircase, Cracked wall of Primary school & Collapsed boundary wall (“Losses of Earthquake”, 2015)

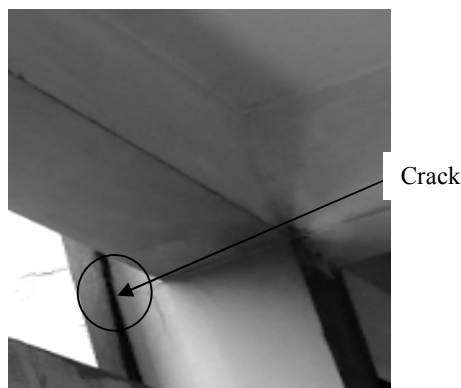
In Khulna district, the Khulna City Corporation Women college Building was terribly damaged. Beams and columns of this building were cracked seriously. A part of this Building was tilted and crack was formed along the beams and columns of the inner face of the building. Cracked beam-column joint is shown in Fig. 6. It was cracked during earthquake due to presence of eccentric beam-column joint. From Fig. 6 it can be seen that the beam was not located centrally with the column. As a result eccentricity was developed at the joint and the joint cracks during earthquake. A cracked column with an uncracked beam is shown in Fig. 7. In this case the stiffness of the beam was more than the stiffness of the column. As a result cracking of column has occurred during earthquake due to formation of plastic hinge in the column. If the column of the building frame was made stronger than the beam then the energy of earthquake can be more uniformly distributed throughout the building. In this system plastic hinge generally form in the beam while the column remains elastic. As a result the structure become partially damaged which may be repairable. The tilted part of the Khulna City Corporation Women College building is shown in Fig. 8. This part was tilted due to differential settlement in the soil layer. Cracks were developed in different beams and columns of this tilted building.

Figure 6: Cracked Beam-Column joint

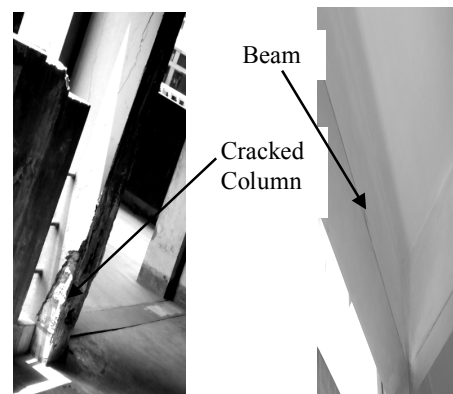
Figure 7: Cracked Column with uncracked beam

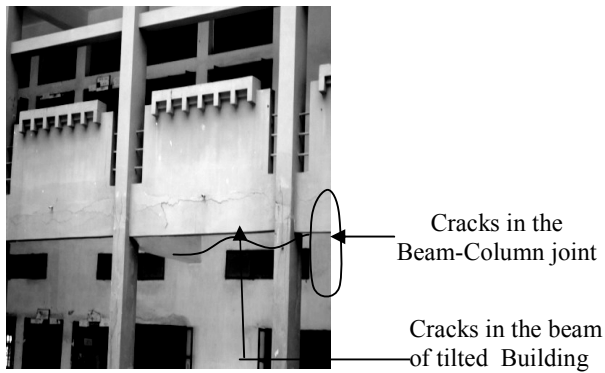
Figure 8: Cracks of tilted Building

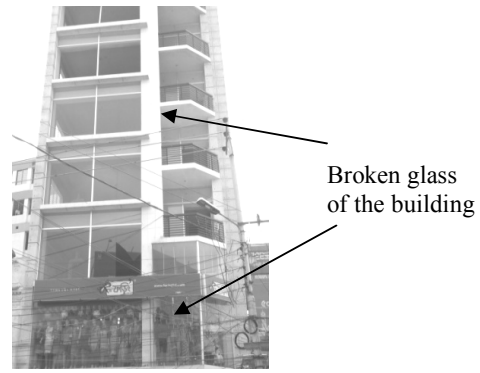
Glass of a commercial building was broken in Shaheb Bazar, Rajshahi. The affected building is shown in Fig. 9. The building is face to the west. Vibration of earthquake was in north-south direction. Due to this vibration tension governs on one side of the structure and compression governs on the opposite side of the structure. But the less stiff glass used in this building cannot stand with this tension and compression phenomenon. As a result it broke. It is seen that annealed and heat strengthened laminated glass exhibited higher resistance to glass fall out during earthquake (Behr, 2001). So for better performance during earthquake these types of glass should be used.

Figure 9: Broken glass of the Building

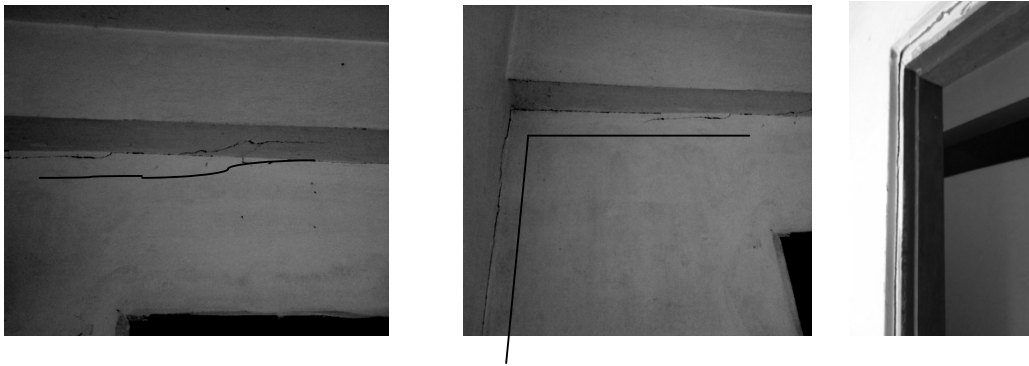
Figure 10: Cracked beam, wall joint and displaced door of the affected building

In Rajshahi another 6 storied building was affected by the earthquake. Cracks were formed in different beams, walls and at the joint of wall with beam and columns. Cracked portion of the building is shown in Fig. 10. The frames of door and window of this building were displaced from their original position by an amount $1/2''$. The elevation of the building is as shown in Fig. 11. From this figure, it can be seen that the building has vertical irregularity. The left side of the building is higher than the right side. So, the mass of left portion of the building is greater than the right portion. Again, the inertia force, generated during the earthquake is proportional to the mass. So, the inertia force generated due to tilting of building in the left direction is greater than due to tilting of building in the right direction. As a result displacement of building in the left direction is more. This uneven displacement of structure due to shake of earthquake was resulted in cracks in different components of the building.

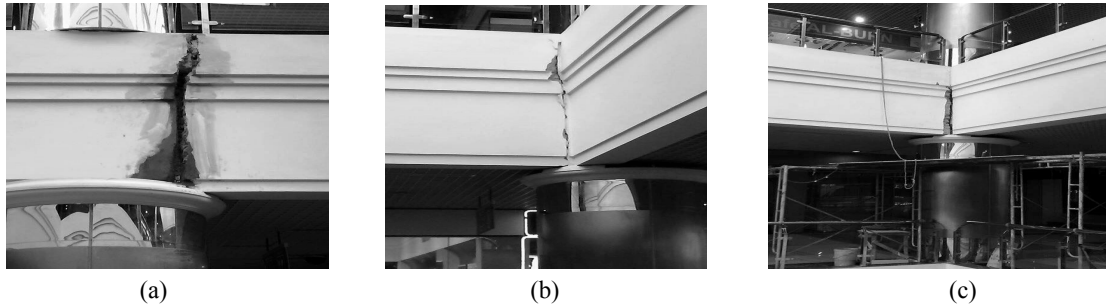
The largest shopping center of Bangladesh “Jamuna Future Park” was also affected by the earthquake. Crack was formed at different Beam-Column joints of this building as shown in Fig. 12. From this figure it can be seen that the beam was not located centrally with column. As a result some eccentricity was induced in this joint. Due to this eccentricity cracking of beam-column joint occur during earthquake.

Figure 12: Cracked Beam-Column joints of Jamuna Future Park Shopping Center

Eccentric beam-column joint make a building vulnerable to earthquake. Building collapses due to eccentric beam-column joint during an earthquake. A research report founded that shear strength of eccentric beam-column joint is reduced by 40% due to seismic force. This results in the collapse of beam-column joint (Hirosawa *et al.*, 2000). So, eccentric beam column joint should be avoided. To avoid eccentricity in joint beam should be connected centrally with the column. Beam-Column joints with and without eccentricity are shown in Fig. 16.
