ASSESSMENT OF DISTRESSED RAILWAY EMBANKMENT IN BANGLADESH

ABSTRACT

The embankment got distressed by Pachuria-Faridpur-Pukuria under the Bangladesh Railway West Zone Project in October 2015 during the reconstruction and rehabilitation of the existing track. Total 11Nos different distressed segments are identified along the alignment, and the segment length ranges from 30-548m. To identify the distressing problem, 93 boreholes were drilled at the distressed segment of the embankment. After that, disturbed and undisturbed samples were collected for detailed laboratory tests. The drilling depth ranged from 20-30m from the top of the embankment. This study has been focused on the stability of analysis of the distressed segments based on Bishop method and Low's approach as well as the possible reasons for this distress. Through the analysis, it has been found that the property of fill material below the required limit. The slope is instable due to the fill material property.

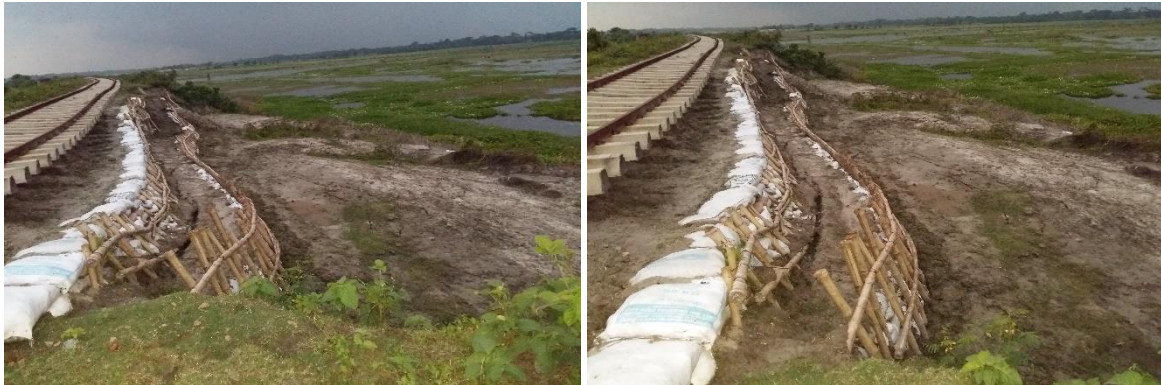
At present, BR has initiated a project aimed at reopening the previously closed 'Pachuria-Faridpur-Pukuria' section. This involves the rehabilitation of the Pachuria-Faridpur section spanning 25.52 km, the reconstruction of the Faridpur-Pukuria section covering 25.8 km, and the construction of a new railway line extending up to Bhanga for a total length of 5 km (Faridpur-Bhanga Section of Bangladesh Railway (West), 2017). The objective of this work is to establish connectivity with the Trans-Padma rail corridor. The initiation of track operations was scheduled to occur in December 2015. The reprofiling and restoration efforts on the existing embankment were nearing completion; however, during the rainy season spanning from July to October 2015, particular sections of the embankment began to exhibit signs of damage (Figure 1). Total 11 Nos different segments having length of 30-548m were identified as significant distress.

Figure 1: Distressed segment of Railway Embankment

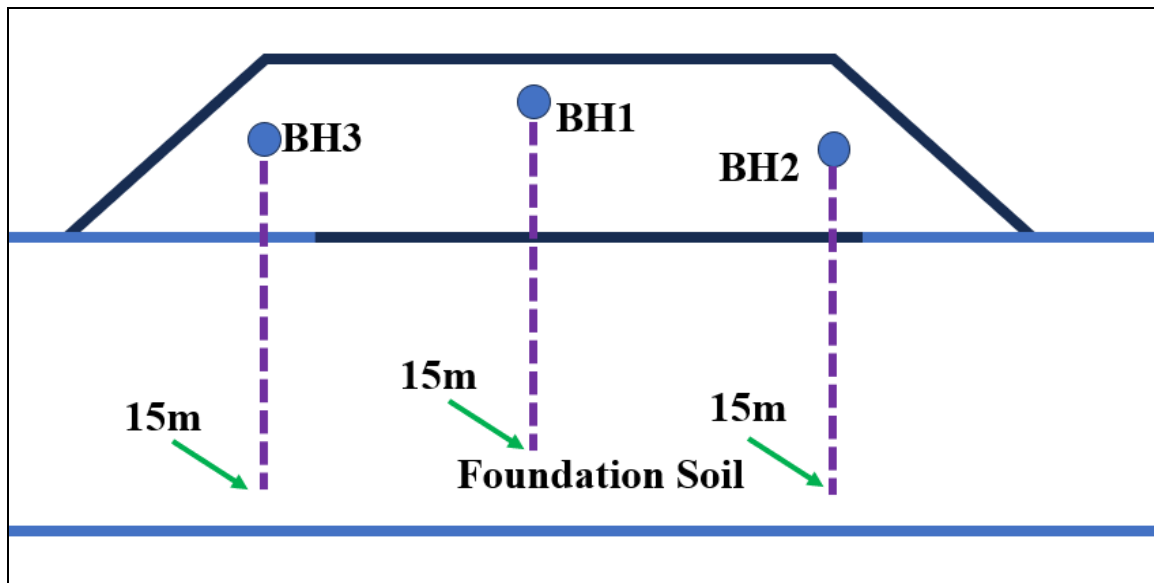
In March 2016, a total of 93 holes were bored along the Bhanga segment following the occurrence of an embankment failure. Standard Penetration Tests (SPT) were carried out in sandy soils at depths of up to 15 m in these holes, which were below 10 m in depth (Figure 2). Soil penetration tests (SPTs) were conducted at regular intervals of 1 meter depth. Auto-trip hammers were utilized to conduct SPTs. Undisturbed samples were collected from clay and silt layers in boreholes using a 100 mm diameter open-drive tube sampler.

Figure 2: Layout of subsoil investigation

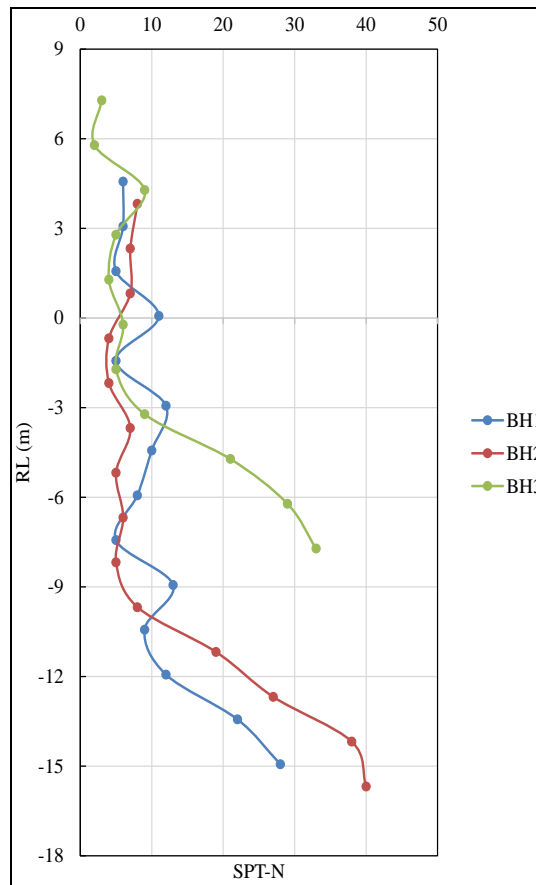
The borelogs display (Figure 4) the N-values acquired from the Standard Penetration Test conducted in the sandy soils found beneath the soft sub-soil composed of grey silty clay. The N-values obtained from Standard Penetration Test (SPT) in the sandy strata, below the soft sub-soil, at depths of 15 m in the boreholes BH1, BH2, and BH3 upto 15m. The N-values of the fill material recovered from boreholes BH1, BH2 and BH3 exhibited significant variation, ranging from 2 to 11. The N-values obtained via SPT in borehole BH1 varied between 0 and 5 for the soft clay beneath the fill. Nevertheless, the N-values obtained from borehole BH2 exhibited a range of 4 to 8. The N-values obtained from the Standard Penetration Test (SPT) in the sandy layers, located below the soft clay, of boreholes BH1 and BH2 varied from 28 to 40 up to a depth of 15 meters.

Figure 4: Variation of SPT-N with Depth

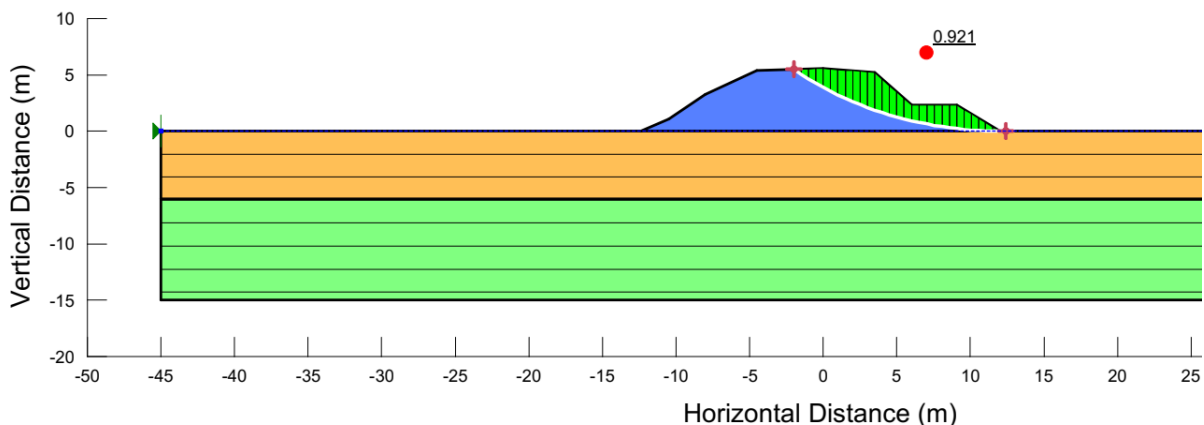
The embankment failure occurred when the height of the fill was gradually increased to around 5 meters. The slope stability assessments of the collapsed embankment section were conducted using the geotechnical data from the investigations. The actual embankment in the field had been considered based on the survey data. The research considered the strength of the fill and clay sub-soil to be 10 kPa and 15 kPa, respectively. The factor of safety calculated using the bishop Method is 0.942 (Figure 5). Soil strength ratings, although idealized, reveal that the soft sub-soil lacked the ability to support the fill soil above it. The slope experienced failure due to sliding (Nasvi & Krishnya, 2019).

Figure 5: Lowest FOS and critical slip surface from Bishop method

The factor of safety by LOW approach has been determined to be 0.79 for a soft clay layer thickness of 5 m, and it decreases to 0.87 for a clay layer thickness of 5 m. It is evident that the clay layer's strength was insufficient to bear the weight of the soil above it, even with a slope ratio of 1:2 (vertical: horizontal). The embankment slope experienced a breakdown. Two additional analyses were conducted to examine the impact of fills and sub-soil shear strength on the stability of the exact same embankment section. In one analysis, the strength of the fill and clay sub-soil was deemed to be 15 kPa each, whereas in the other analysis, they were considered to be 20 kPa each. In the former scenario, the factor of safety achieved is 1.03, while in the latter situation it is determined to be 1.1. These findings indicate that as long as the clay layer possessed an undrained shear strength over 20 kPa, the embankment segment would not have experienced failure when the level of the filling was limited to 5m. Based on the stability analyses conducted, it is clear that the failure of the embankment might be related to the presence of a highly compressible sub-soil layer on which the fill was laid. The soft clay beneath is insufficient to sustain the complete embankment height without enhancing the ground conditions.
