DESIGNING A ROUNDABOUT HAVING CENTRIPETAL MOTION WITH PROVISION FOR PEDESTRIAN AND BICYCLE FACILITIES:A CASE STUDY FOR 5 LEGGED INTERSECTION

N. Haque*¹, S. M. Mashrur¹, T. Saha¹, N. R. Khan¹, A. Mahmud¹, M. M. Hoque², M. Hadiuzzaman³

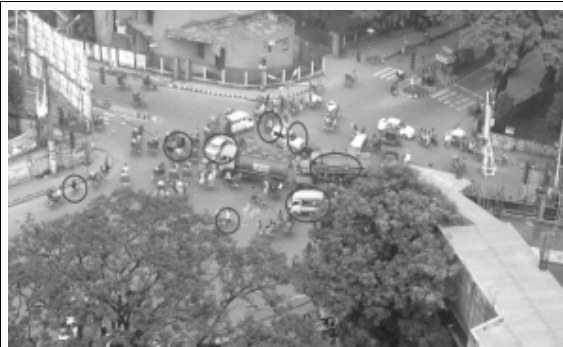
Figure 2: Heterogeneous Traffic System

In Figure 2, it is seen that 8 types of vehicle comprising both NMV and motorized vehicles clogged together in the middle making congestion at the intersection, which is a major issue.

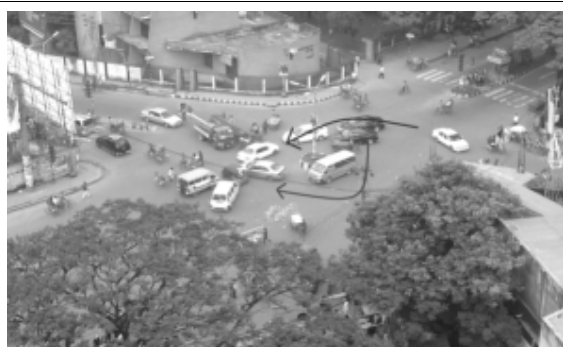
Figure 3: Tendency of taking anticlockwise rotation

At roundabout, there has to be clockwise rotation in circular path for all traffics. But in the Polashi intersection we found that some drivers have a tendency to take shortcut by rotating in anticlockwise direction (Dark arrow) making congestion by blocking the traffic that is rotating in clockwise direction (Bright arrow), shown in Figure 3. A circular path of larger diameter may solve this problem.

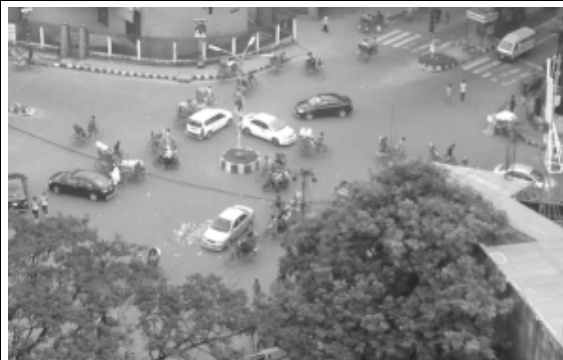
Figure 4: Absence of Channelization

Both NMV and motorized vehicles are moving at Polashi intersection in a haphazard manner. There is no channelization for particular traffic which makes it more accident and congestion prone intersection as shown in Figure 4. Also there is no special facility for bicycle.

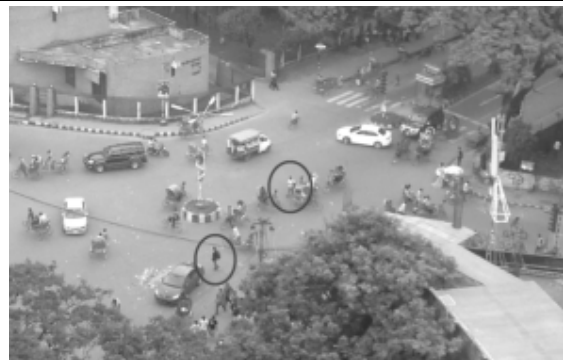
Figure 5: Pedestrian Safety Hazards

Pedestrians are the most vulnerable road users yet they are the most ignored in the existing traffic system. They were crossing the intersection risking their own lives as shown with the marked pedestrian with white t-shirt in Figure 5. No foot over bridge or any other facility was seen in Polashi intersection.

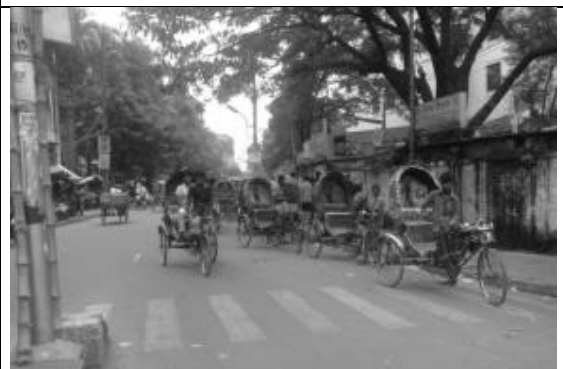
Figure 6: Side Friction

In all approaches, due to lack of law enforcement there was unauthorized parking especially of Rickshaws, shown in Figure 6, reducing the capacity of the approaches by a large extent. It was also boosted by introduction of some roadside shops attracting buyers, making congestion for moving vehicles in the link.

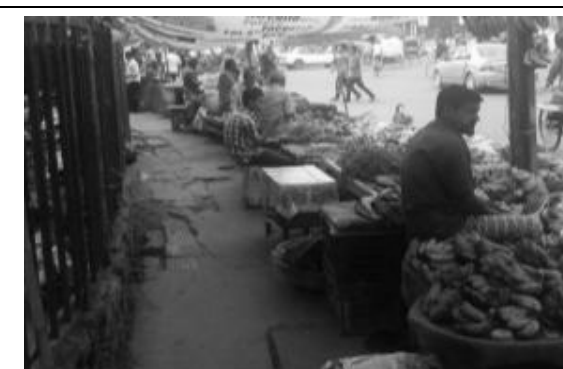
Figure 7: Ineffective Footpath

Roadside shops are situated on footpath making it ineffective and forcing pedestrians to use the road instead of footpath. Figure 7 shows the extent of footpath width which is reduced by these frictions.

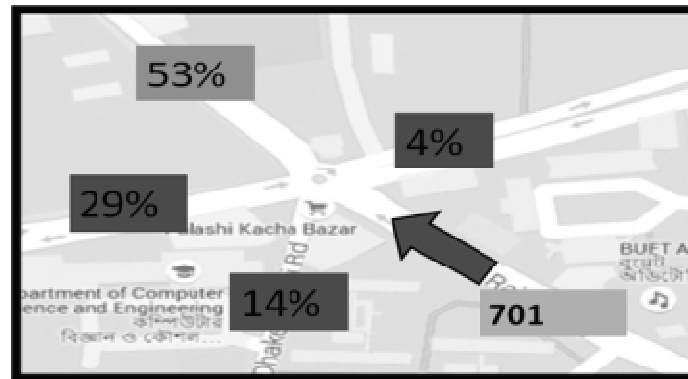
Figure 14: From BUET to other directions

On the second day of our survey, directional flow from each direction to other directions was measured and it was found that the maximum percentage of vehicles go to the through direction in every case. Sample size to find out directional flow is given in Table 1. Total number of vehicle is also provided in corresponding Figures 10~14.

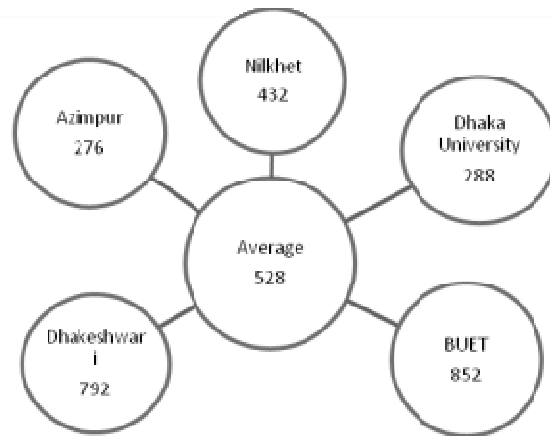
Figure 16: Pedestrian Crossing per Hour in each link

Pedestrians are the most vulnerable users of road. The numbers of pedestrian crossing different roads per hour are given in the Figure 16. In BUET road, there are many students crossing the road. Average number of pedestrian crossing in all roads is 528, which is very alarming. This is the reason for providing special facility for pedestrians.
