## ROAD WORK ZONE SAFETY PROBLEM AND ASSOCIATED RISK FACTORS IN BANGLADESH: AN AUGMENTED ANALYSIS INTEGRATING CRASH AND OBSERVATIONAL DATA

Road work zone is an inevitable traffic mobility impediment. It poses a challenge to traffic operation and management and, thus, creates potential safety hazards for road users. The safety of a road work zone demands special attention, as unanticipated traffic situations may attune unexpected crash phenomena. Therefore, appropriate and pellucid information and guidance to road users is a fundamental requirement in a work zone. Bangladesh, however, needs to improve these provisions and standard safety measures. It is essential to understand the current best practices, characteristics, and probable causes of work zone crashes to develop standards for the country. The study aims to evaluate the features of crashes that took place at the road work zones in Bangladesh during 1998-2015 by analyzing the crash records maintained by Bangladesh Police. The characteristics analysis of crashes revealed that most of the crashes occurred were fatal in nature. Moreover, overspeed and reckless driving were responsible for major proportion of crashes at work zo

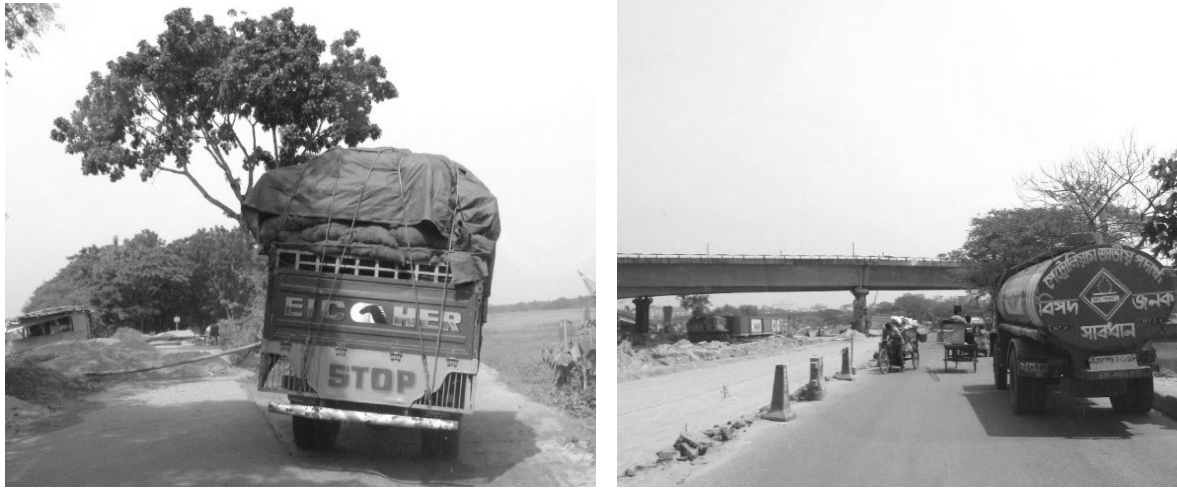
Figure 3: Typical scenarios of absence of advance warning signs at work zones in Bangladesh

During the investigations it was a common observation that, appropriate advance warning sign from adequate distance was absent. Advance warning signs including ‘road work ahead’, ‘lane closed’ and speed restriction signs were not found. This creates confusion among drivers and creates the potential for traffic conflict or even a crash in extreme case.

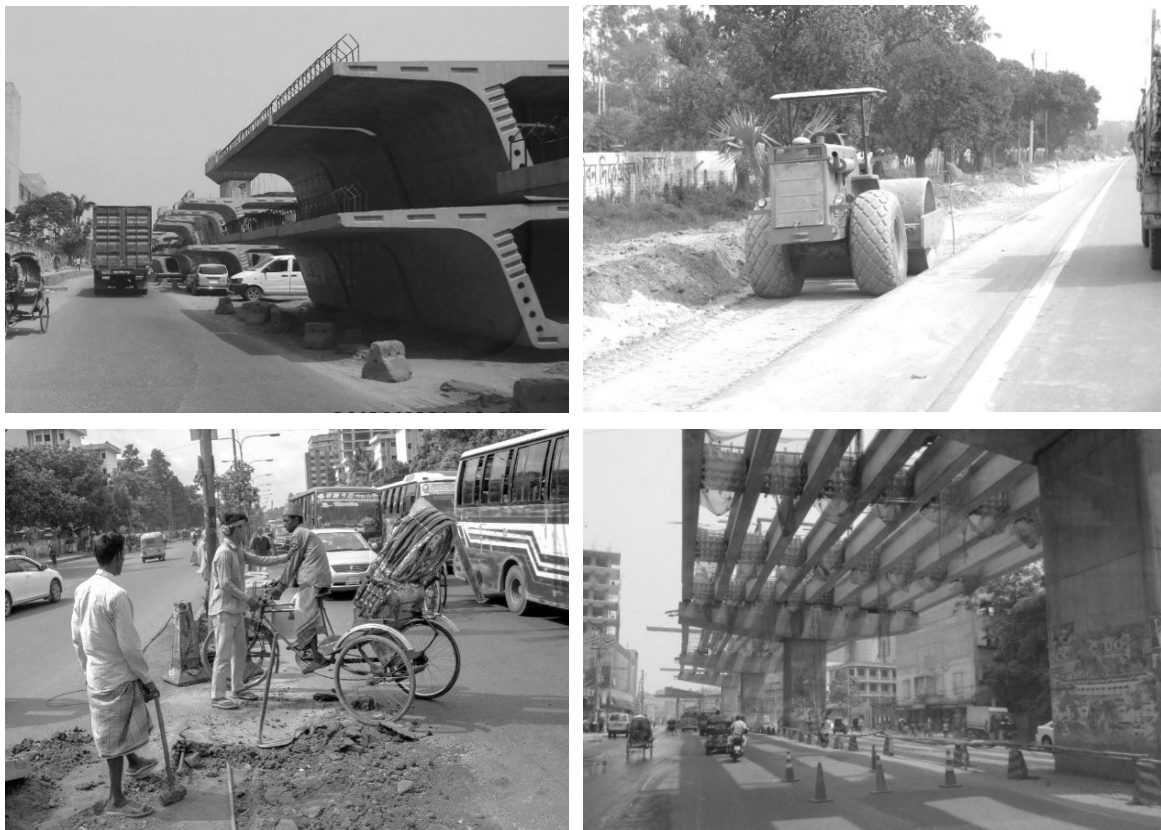
Figure 4: Common scenarios of absence of appropriate safety barriers at work zones

Absence of delineators and safety barriers was also a common phenomenon (even for mega project works of Bangladesh) which could increase the crash severity significantly. Moreover, for overhead construction works, adequate protection to restrict falling objects to ensure safety of pedestrians and use of proper fall protection gears by workers was also not found as well.

During the investigation, it was also observed that rocks, concrete blocks and tree branches were used in some work zones for delineation purpose which is extremely unsafe. In few cases, the practice of using traffic cones was found, however, those were not placed in proper manner. The cones were placed just before the work zone which were unable to guide the traffic properly. To ensure the movement of traffic without conflict, the cones should be placed to make proper taper for merging the vehicles. In this regard, the ‘zone concept’ of work zone should be followed as outlined in Figure 1. This concept allows to segregate the whole work zone into five segments to allow free traffic flow and ensure adequate safety of road users at work zones. These zones are termed as advance warning area, transition area, buffer area, work space and termination area.

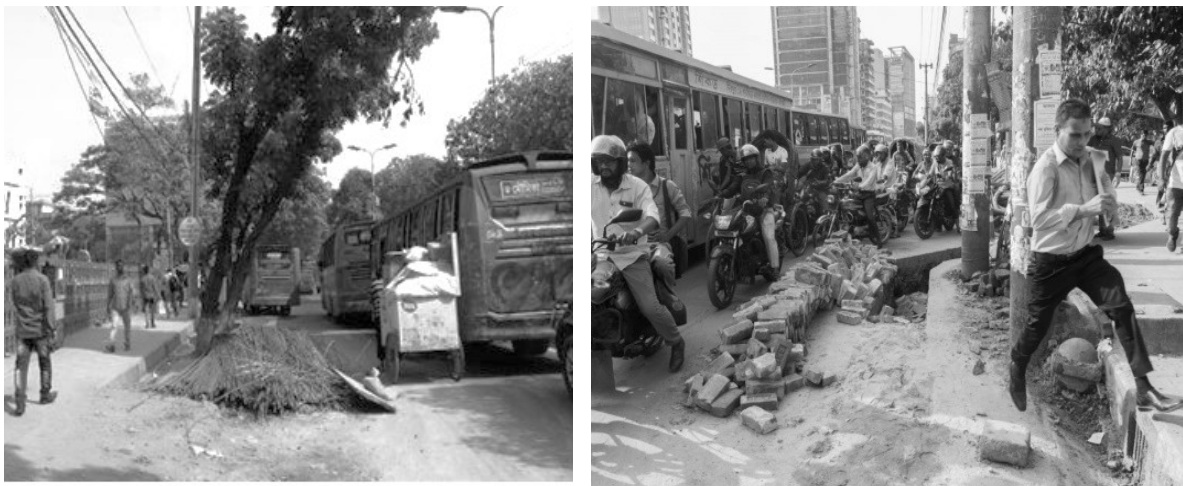
Figure 5: Typical scenarios of exposure of construction and repair materials without adequate protection

Dumping and storage of construction and repair materials e.g. sand, gravel, blocks, rocks, excavated materials, steel bars or rods etc. on the road without any protection were common practices in the work zones. Moreover, these materials were not found to be conspicuous, and thus create extreme hazard for the users, especially on high-speed road at night-time for two or three-wheelers like motorcycles, CNG autorickshaws and so on. Moreover, after completion of works, most of the work zones are not maintained and repaired properly to be like the initial state. Too much sand, gravel, and mud are left on the road pavements. These create serious sliding hazards for different road users, particularly for the motorcyclists.

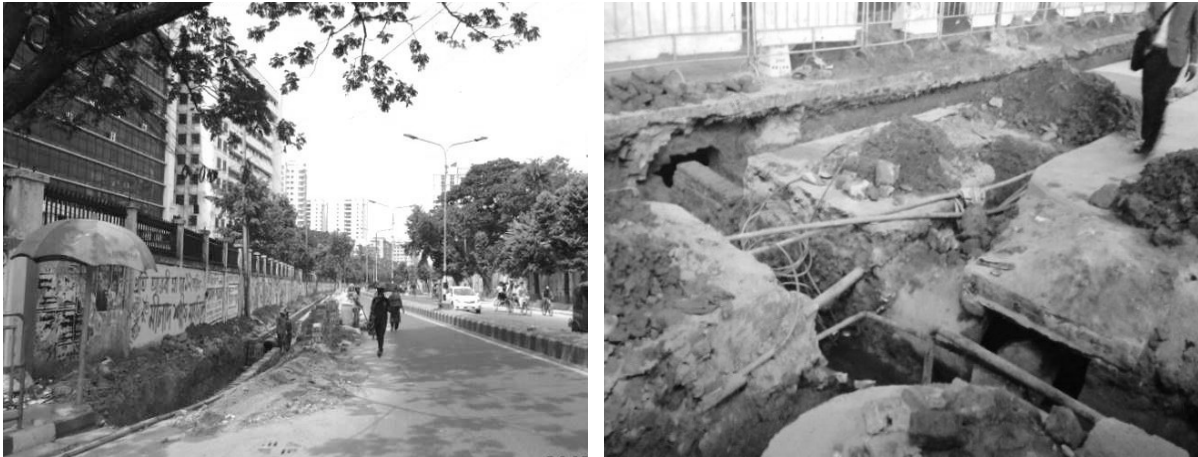
Figure 6: Common scenarios of absence of pedestrian facilities at work zones

It was also found that the needs of pedestrian are neglected or ignored at road work sites. In most of the cases, there is no space for the pedestrians, and they were forced to move along with traffic without any protection since the walking space or footpaths were found to be used for road works activities. Actually, the contractors or supervisors are not conscious of pedestrian safety hazards and do not consider the need of pedestrian facilities. Ultimately, the pedestrians are compelled to walk across the work zone in a very risky manner which is a common scenario.

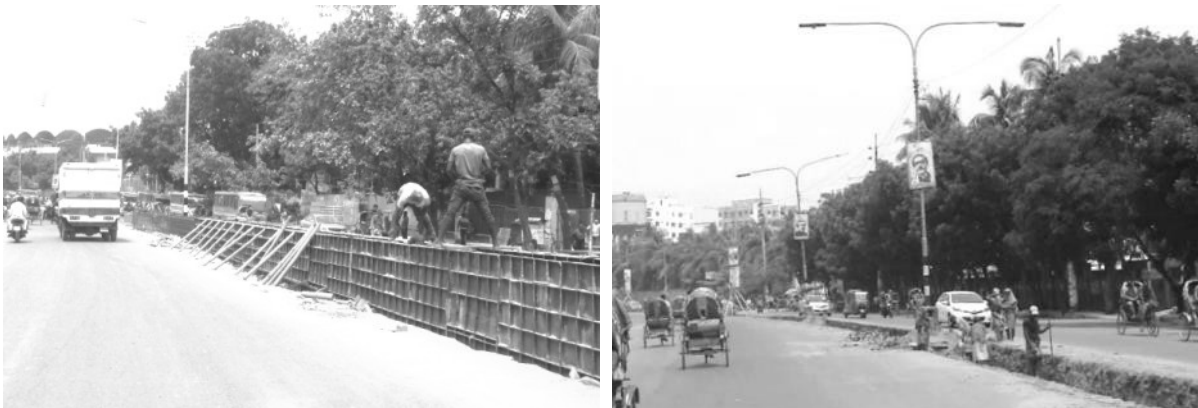
Figure 7: Common scenarios of negligence of safety by workers at work zones in Bangladesh

The workers were not found to use Personal Protective Equipment (PPE) in most of the cases (except few mega projects) during the investigation. Moreover, they were also found to work in risky manner due to lack of adequate training. Therefore, all workers should be provided with proper PPE before starting work and get proper training on regular basis. Moreover, the placement of traffic controller or flagger was also observed to be in wrong position at work zone. Additionally, they were not provided with standard ‘Stop’ or ‘Slow’ bat. This is a very crucial issue, especially for high-speed roads to prevent crash and subsequent casualties.
