ASSESSING THE EFFECTIVENESS OF INCLUSIVE BUS TERMINAL DESIGN IN MEETING THE NEEDS OF PHYSICALLY CHALLENGED PEOPLE: IN THE CONTEXT OF KHULNA

P.S. Anik*¹, M.S.R. Shovon ² and A. Rahman ³

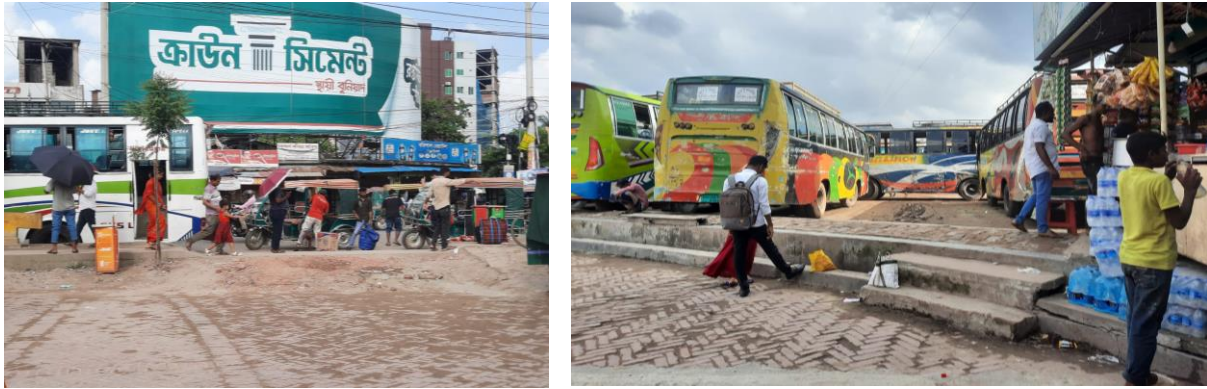
Figure 5: Entry of the terminal building blocked by mounted earth (Left), Walkway ends at the front of a shop (Right)

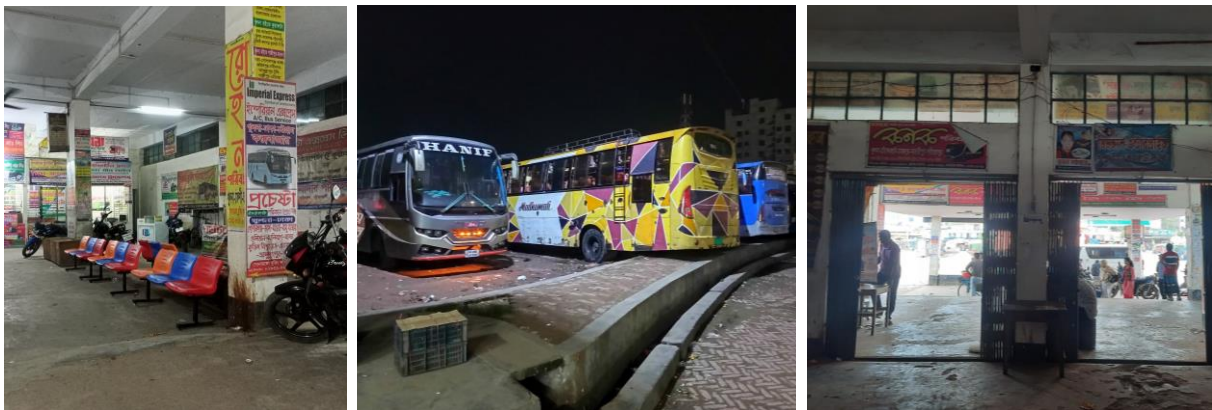
Unauthorized bike parking within the terminal area requires more management oversight. The public toilet, despite having a designated accessible toilet, is consistently closed and situated within the main entry lobby, hindering the movement of physically challenged individuals due to high foot traffic.

Figure 6: Seating area (Left), Walkway is blocked by bus parking (Middle), Entry (Right)
