LESSONS LEARNED FROM NEPAL EARTHQUAKE (M 7.8): DAMAGE BEHAVIOUR OF BUILDINGS IN BANGLADESH

M.R. Awall¹, M.A. Rahman^{*2}, K.M.S. Uddin³

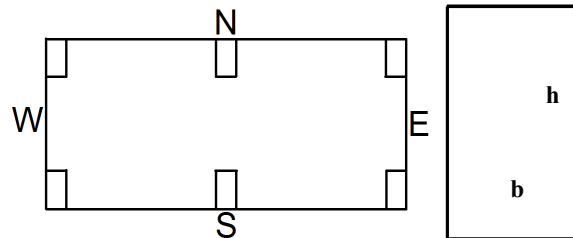
Figure 15: Orientation of column in plan

Orientation of column in a plan of a building is very important. It will affect the stiffness of the building. Consider the plan as shown in Fig. 15. Moment of inertia of the building is greater in east-west direction. So the building is weaker in north-south direction and stronger in east-west direction. Assume the column section of

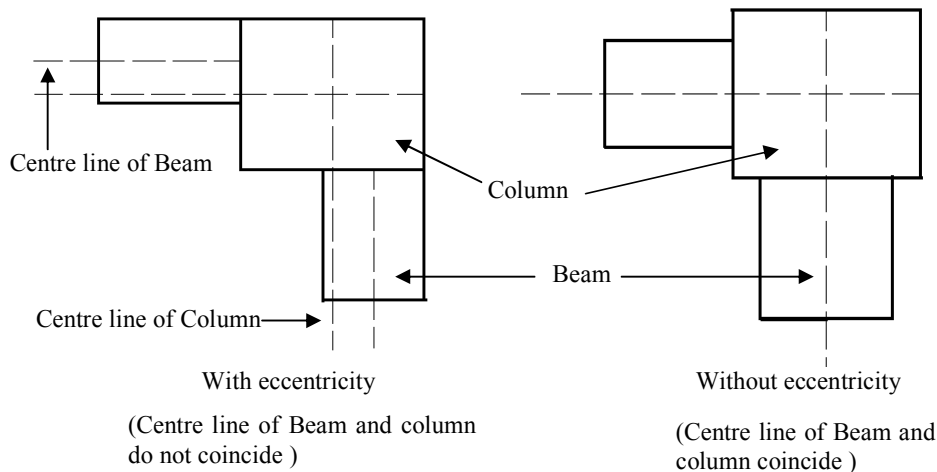
Figure 16: Beam-Column joint with and without eccentricity

Eccentric beam-column joint make a building vulnerable to earthquake. Building collapses due to eccentric beam-column joint during an earthquake. A research report founded that shear strength of eccentric beam-column joint is reduced by 40% due to seismic force. This results in the collapse of beam-column joint (Hirosawa *et al.*, 2000). So, eccentric beam column joint should be avoided. To avoid eccentricity in joint beam should be connected centrally with the column. Beam-Column joints with and without eccentricity are shown in Fig. 16.

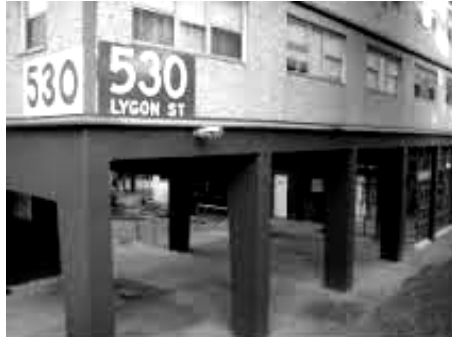
Building with soft Storey

If any storey of a building has stiffness less than 70% of the stiffness of the storey immediately above it or less than 80% of combined stiffness of three stories above, then it is called a soft storey. Presence of soft storey in the structure will make it vulnerable to earthquake. Due to presence of soft story excessive drift occur in that story. However, excessive drifts in the story coupled with p-delta effects on the yielded columns make buildings collapse (Hejazil *et al.*, 2011). Figure 17 shows the presence of soft storey in a building and its effect.
