ASSESSMENT OF DISTRESSED RAILWAY EMBANKMENT IN BANGLADESH

ABSTRACT

The embankment got distressed by Pachuria-Faridpur-Pukuria under the Bangladesh Railway West Zone Project in October 2015 during the reconstruction and rehabilitation of the existing track. Total 11Nos different distressed segments are identified along the alignment, and the segment length ranges from 30-548m. To identify the distressing problem, 93 boreholes were drilled at the distressed segment of the embankment. After that, disturbed and undisturbed samples were collected for detailed laboratory tests. The drilling depth ranged from 20-30m from the top of the embankment. This study has been focused on the stability of analysis of the distressed segments based on Bishop method and Low's approach as well as the possible reasons for this distress. Through the analysis, it has been found that the property of fill material below the required limit. The slope is instable due to the fill material property.

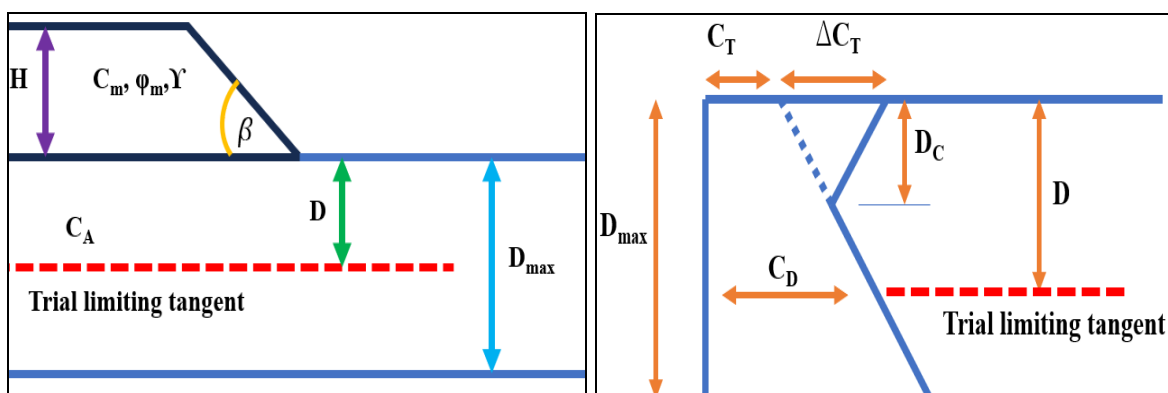
Figure 3: Description of embankment over soft ground

The stability of the embankment has been analyzed using the methodology introduced by (Low, 1989). Embankments founded on soft clay the ground commonly face the risk of failure due to a circular slip surface that extends into the soft ground (Figure 3). A limitless number of tangent circles can be constructed, all tangential to a specified trial limiting tangent. Out of all the potential slip circles that pass along the soft foundation, the critical circle provides the lowest safety factor.
