MORPHOLOGICAL CHANGES AT THE ESTUARY OF PUSSUR-SIBSA RIVER SYSTEM AND ITS RESPONSE TO DREDGING.

Keywords: Estuary, Pussur River, Dredging, Siltation, Navigation

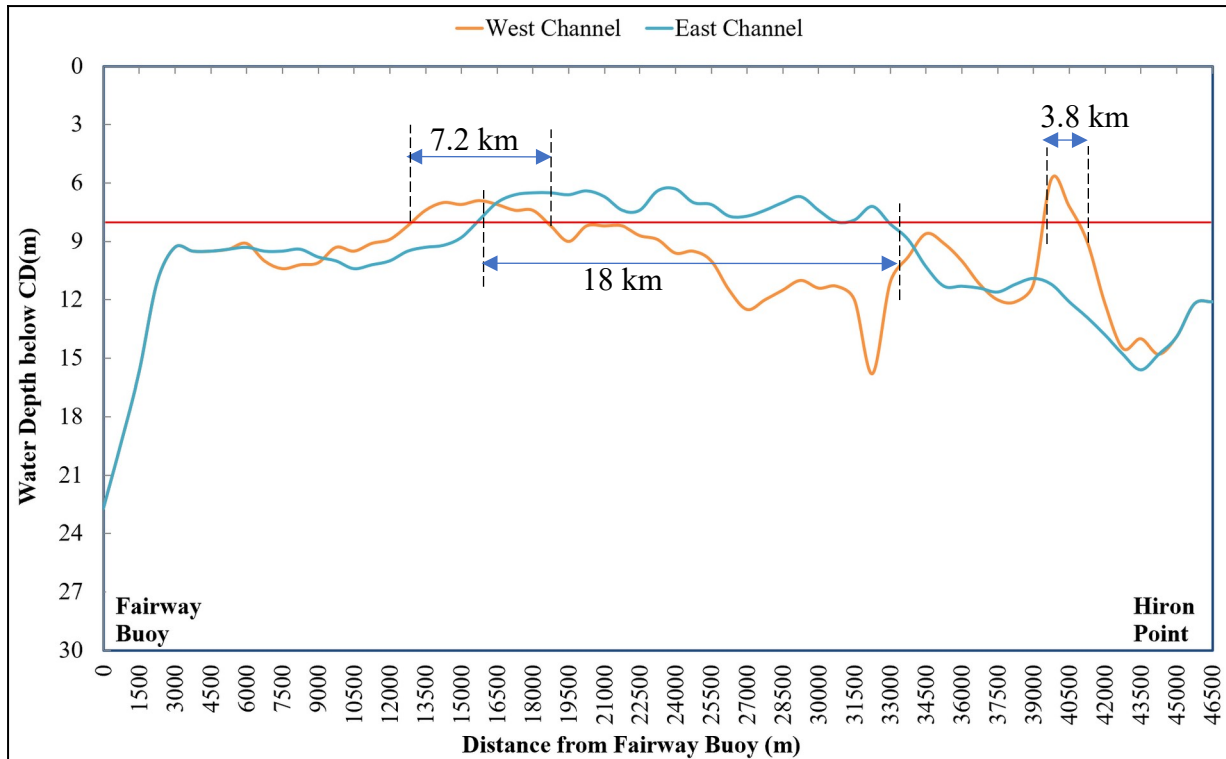
Figure 2: Long profile of east and west channel at Outer bar area.

The survey charts of 2006 to 2019 was analyzed to assess the pattern of morphological changes. Since the dredging was carried out in 2019-20, the pre survey charts, post survey charts and chart of 2021-23 has been analyzed to find out the siltation rate and morphological response to dredging. The long profile of east and west channel before dredging has presented in Figure 2. The east channel is and west channel follows same alignment upto 9 km from fairway buoy. The shoaling effect in west channel starts 3 km earlier than east channel. However, along the full west channel (upto Hiron Point) two segments of 7.2 km and 3.8 km i.e total 11 km is less than 8.5m CD. But along the east channel around 18 km is less than 8.5m CD. Considering the length and volume of dredging as well as the stability of Channel, the west channel was selected for dredging.

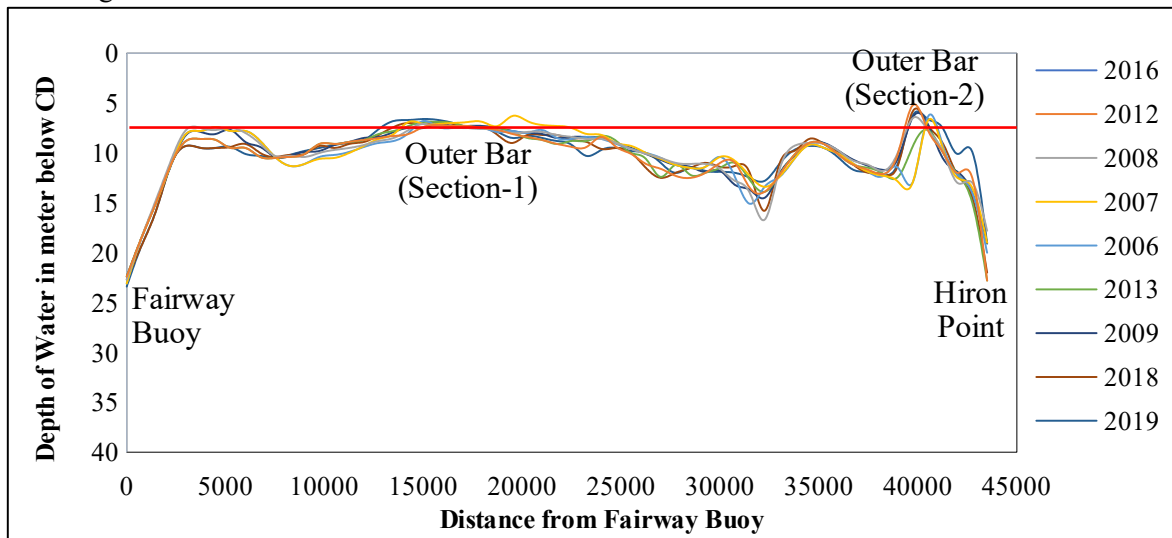
Figure 4: Long profile of West Channel for the year 2006-2019.

The hydrographic survey charts of 2006-2019 along the west channel has been analyzed (Figure-4). From the analysis, it's found that Section-1 is almost stable at a depth of 7.5m over the one and half decade. However, in Section-2, around has been scoured in mild pattern naturally. The average depth in this section is around 6.5m. These areas were dredged in 2020 upto 8.50 m CD depth. Two third of dredged material was disposed near fairway buoy where the water depth is more than 20 m. The remaining one third of dredged material was disposed near Dubla Island. The alignment, depth and dredged quantity of these two sections is described in Table-1.

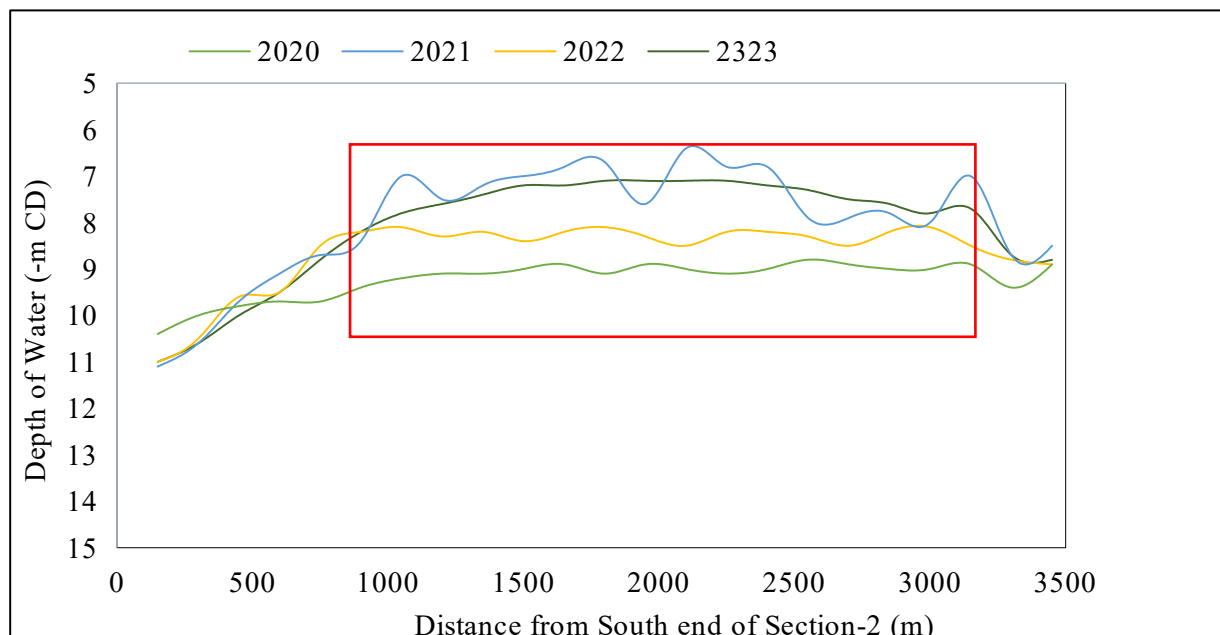
Figure 6: Long Profile of Outer Bar (Section-2)

Depth of cutting at section- 2 was higher than section-1 and was not fully aligned with the flow direction. In 2020, this section was dredged to around 9.0 m and after one year of dredging the depth was reduced to 7.0m. To keep the channel navigational, it was dredged to more than 8.0m in 2022. But in 2023 it has again reduced to near 7.0 m and need to dredge again. The siltation rate in this section is about 1-2m/ year. The comparative bed profile of this section is presented in figure 6. Based on the above analysis, the actual siltation rate in dredged channel was analyzed, which has been presented in Table 2.
