## BOND BEHAVIOR AT EXTERIOR BEAM COLUMN JOINT OF LOW STRENGTH CONCRETE UNDER CYCLIC LOADING

### ABSTRACT

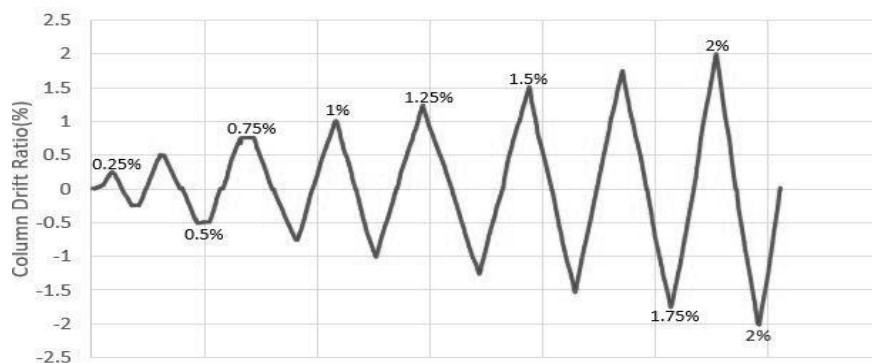
Figure 2.2: Loading Configuration

The maximum vertical load capacity 360 kN for the setup. The vertical jacks applied a constant axial load with an axial load ratio of 0.10. So, we applied 36 kN total in both jacks. Horizontal load is applied to simulate the seismic load by HORIZONTAL jack to obtain the drift ratio. The drift ratios for the cycles were as follows: 0.25%, -0.25%, 0.5%, -0.5%, 0.75%, -0.75%, 1%, -1%, 1.25%, 1.25%, 1.5%, -1.5%, 1.75%, -1.75%, 2%, -2%, 2.5%, -2.5%.....up to ultimate failure.

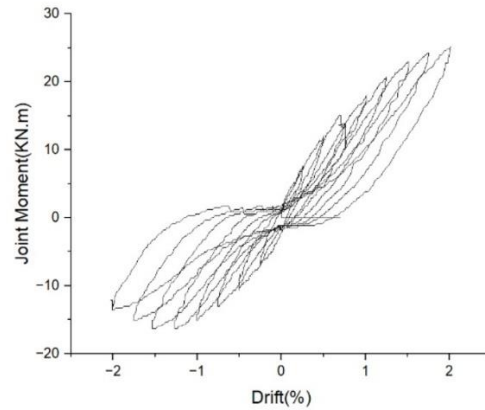
Fig. 4.2: Joint moment vs drift ratio curve for SP-2

This analysis focuses on bond behavior variations between concrete strengths. The load-slip responses offer insights into exterior joint bonds. The experimental results reveal joint behavior differences based on concrete strength. The 10 MPa specimens displayed maximum moments of 17.74 kN-m, 12.71 kN-

7<sup>th</sup> International Conference on Civil Engineering for Sustainable Development (ICCESD 2024), Bangladesh m, and 8.28 kN-m, while the 25 MPa specimen peaked at 25.13 kN-m. For 10 MPa specimens, curves exhibit gradual slip increase until peak resistance, followed by softening. Conversely, the 25 MPa specimen, with higher strength, is expected to display a stiffer response.

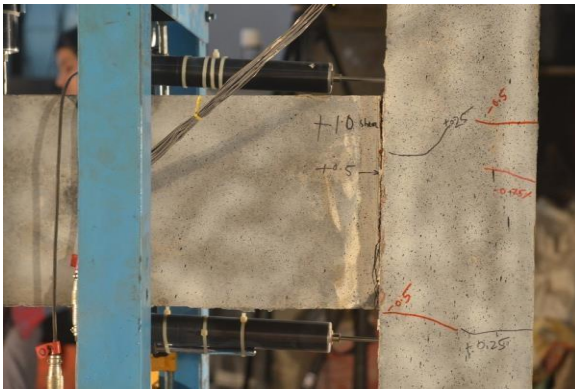
Fig. 4.7: Failure Mode of Specimen-3

In Specimen-1, it is observed that at -0.5% drift ratio, horizontal crack has started to propagate. When the drift ratio increases to 0.75%, there is a visible crack in the beam column interface and this crack widens with increasing drift ratio. At -1% drift ratio, we can see some diagonal crack at beam column joint. In -1% drift ratio, crack occurs in beam also. So, specimen-1 has failed in Shear failure. In Specime-2, it is observed that at both +0.5% and -0.5% drift ratio, horizontal crack has started to propagate at beam column joint. There is also a crack at beam column interface at 0.5%. There are more horizontal cracks observed at 0.75% drift ratio. When the drift ratio increases to 1%, we can see some diagonal at beam column joint. At 1.5% drift ratio we see some vertical crack in the beam. Moreover, it is sighted that cyclic loading has done serious damage to the structure splitting the beam from column. So, specimen-1 falls under Shear failure. In Specime-3, it is observed that at 0.25% drift ratio, horizontal crack and diagonal crack have started to occur. When the drift ratio increases to 0.5%, there is a visible crack in the beam column interface and this crack widens with increasing drift ratio. There is also crack in column at this drift ratio. At 1% drift ratio, the specimen fails at beam column interface with loud cracking sound. So, specimen-3 has failed in Shear failure. In Specime-4, it is observed that at both +0.75% drift ratio, diagonal crack has started to propagate at beam column joint. There is a crack at beam column interface at -1.25%. There are also some diagonal and horizontal cracks observed at -1.25% drift ratio. When the drift ratio increases to -2%, we can see some vertical crack at beam. So, specimen-4 falls under Shear failure.
