DEVELOPMENT OF A SIMPLE TREATMENT SYSTEM FOR MICROPLASTIC POLLUTION IN WATER ENVIRONMENT

ABSTRACT

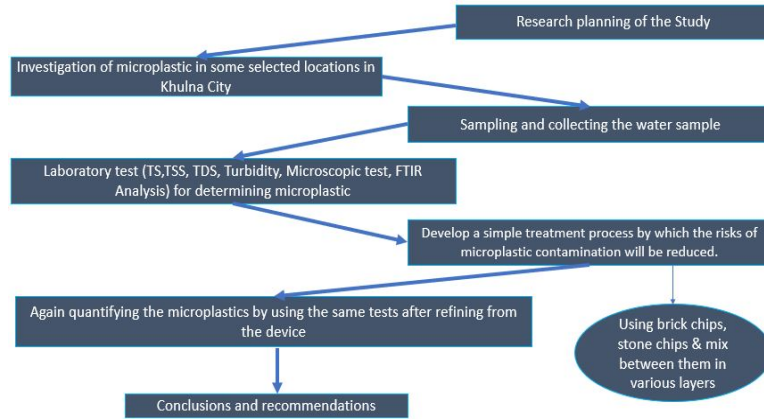
Figure 1: Flow diagram of the experimental procedure

The flow diagram of the whole experimental procedure is depicted in Figure 1.

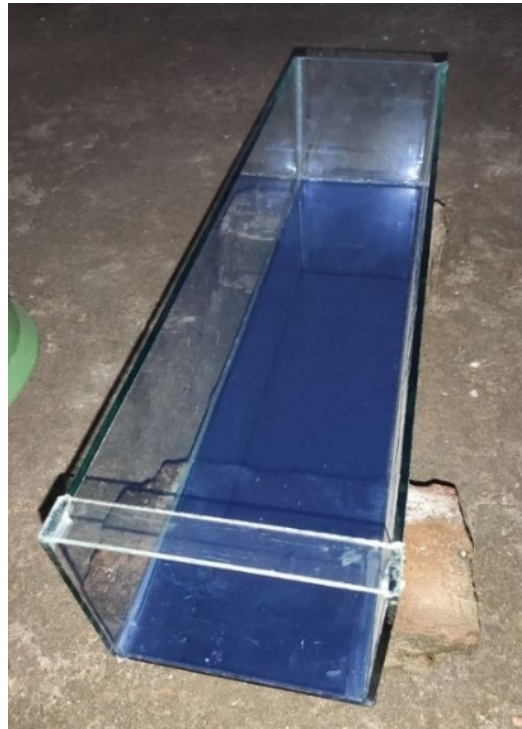
Figure 2: Glass made open channel drain

A 6 inch width and 24 inch length, horizontal drain setup was built by 5m.m. depth glass plates. And it was made sure that samples can't leach from the sides of it. One end was closed with a glass plate and the other end was open.

The vertical drain was made and the description is in section 2.3. Then different materials like brick chips, stone chips, and gravels were collected. The normal size of each material was 0.5-1.3 inch. At first, all the materials were washed well with water. Then it was dried.

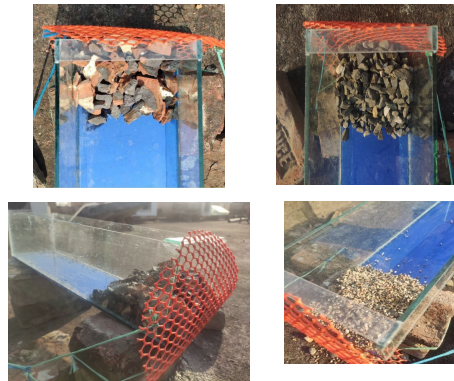
Figure 5: Various layers of a combination of materials to retain MP

The combination between brick chips, stone chips and also the combination of two layers were set and tested for water quality parameter. 3 inch and 6 inch layer were formed separately.

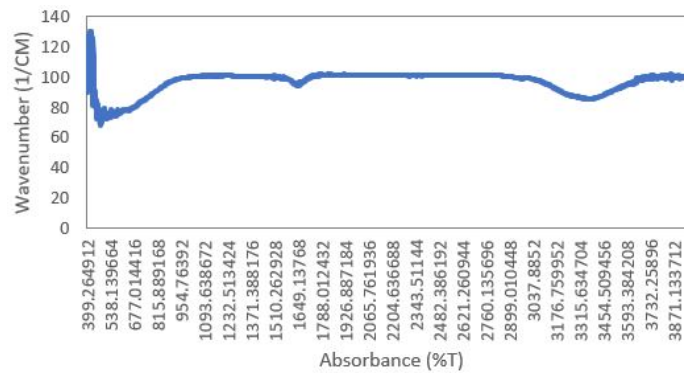
Figure 7: FTIR Analysis graph of testing location 1

Samples were collected from sampling sites. Two samples were tested. The result of the graph is shown below. Which are location 1 and location 2.

The FTIR analysis test proves that there is the presence of microplastics. There is a relation between the wavenumber and absorbance of a tested sample. The lighter the atoms the higher the frequency of wavenumber. This means the concentration of microplastics is much lower if the frequency is high. From the figure, three peaks in the graph were identified. The lowest wavenumber 67.96/CM was found at absorbance 474.488(%T). This test result indicates the presence of microplastics. Another two down-peaks were likely to be less susceptible.

The first objective of this study was to identify the microplastics. The FTIR analysis test proved that the samples contained microplastics. Though the amount was so less. The sharp dark sticky lines are suspected as microplastics. The relation between the wavenumber and absorbance of a tested sample has already been presented above. The lighter the atoms the higher the frequency of wavenumber. This means the concentration of microplastics is much lower if the frequency is high. Three significant peaks in the graph were identified. The lowest wavenumber 67.96/CM was found at absorbance 474.488 %T. This test result indicates the presence of microplastics. Another two down-peaks were likely to be less susceptible. The second objective of this study was to minimize the microplastic in the water environment. Laboratory analysis for the following samples obtained value for filtering from Brick chips, Stone chips and it's mix between these materials by providing 3-inch and 6-inch depth. The value showed for Brick chips, Stone chips and Mixes of 3 & 6-inch values are respectively TS (1390, 65, 84, 1140, 142, 109, 993, 127, 78 mg/L), TDS (200, 57, 79, 910, 98, 68, 930, 74, 41 mg/L), TSS (90, 8, 5, 230, 44, 41, 63, 53, 37 mg/L), Turbidity (0.94, 1.51, 11.8, 0.88, 8.71, 9.1, 1.47, 6.2, 7.5 N.T.U). For this study, various water sample conditions were checked. Test results indicated that microplastic concentration and rates both were significantly reduced by using the simple filter technique. Because the values of TDS, TS, and TSS of each value were satisfied. Also, Turbidity values indicated the same. And at last Microscopic examination test results are well to prove that MP was reduced.

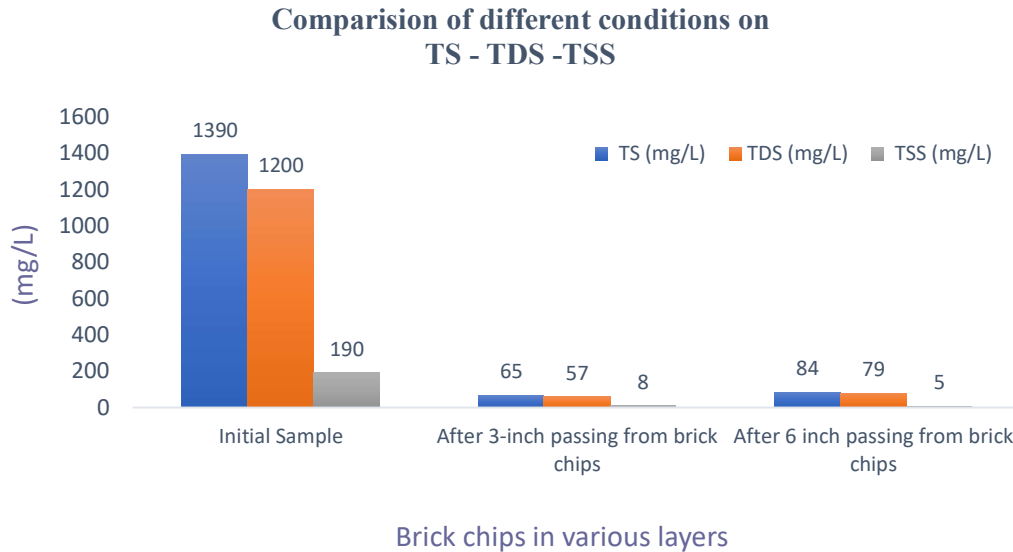
At first, brick chips layers were provided. The graph regarding the values represents different values of TS, TDS and TSS.

Initially, TS value was 1390 mg/L. The same MP sample was pass through the 3 inches layers of brick chips and the value became significantly lower. It was 65 mg/L after passing from the filter layer. And 84 mg/L after passing from 6 inches layers of brick chips. The TDS and TSS values were significantly reduced. The values of TDS initially and after passing from 3 and 6 inches layers of brick chips are 1200 mg/L, 57 mg/L and 79 mg/L respectively. TSS values are 190 mg/L, 8 mg/L and 5 mg/L respectively.

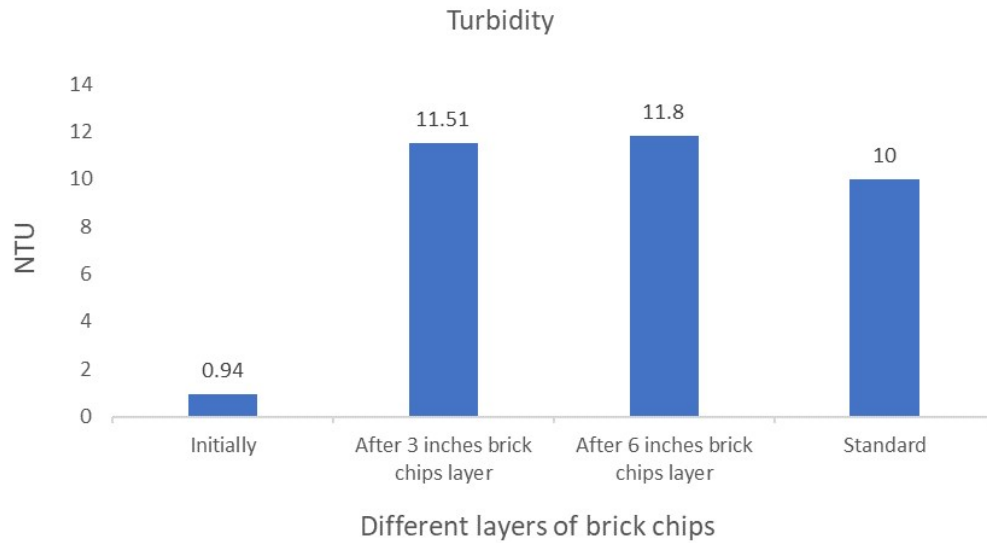
Turbidity :

Initially turbidity of sample water was so low which is 0.94 NTU. After passing from 3 and 6 inches of brick chips layers the turbidity value became much higher. Which are 11.51 NTU for 3 inches and 11.8 NTU for 6 inches. It indicates that there is less amount of microplastics present after passing through the filters.

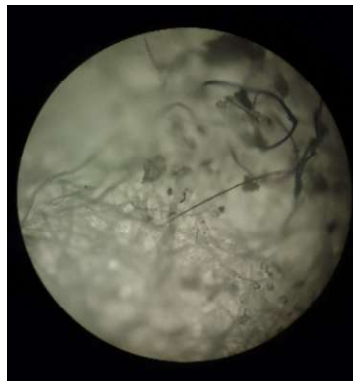
Figure 9: Microscopic view of MP Initial and after filtering (Brick Chips) the sample

Initial Sample

After passing from 6 inches layers of brick chips

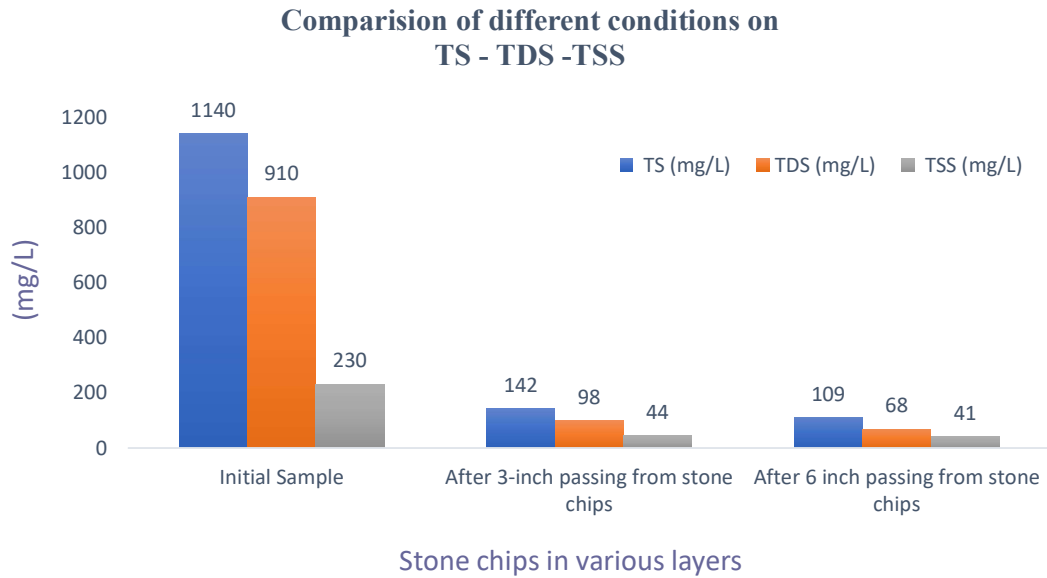
Initially, TS value was 1140 mg/L. The same MP sample was pass through the 3 inches layers of stone chips and the value became significantly lower. It was 98 mg/L after passing from the filter layer. And 109 mg/L after passing from 6 inches layers of brick chips. The TDS and TSS values were significantly reduced. The values of TDS initially and after passing from 3 and 6 inches layers of brick chips are 910 mg/L, 98 mg/L and 68 mg/L respectively. TSS values are 230 mg/L, 44 mg/L and 41 mg/L respectively.

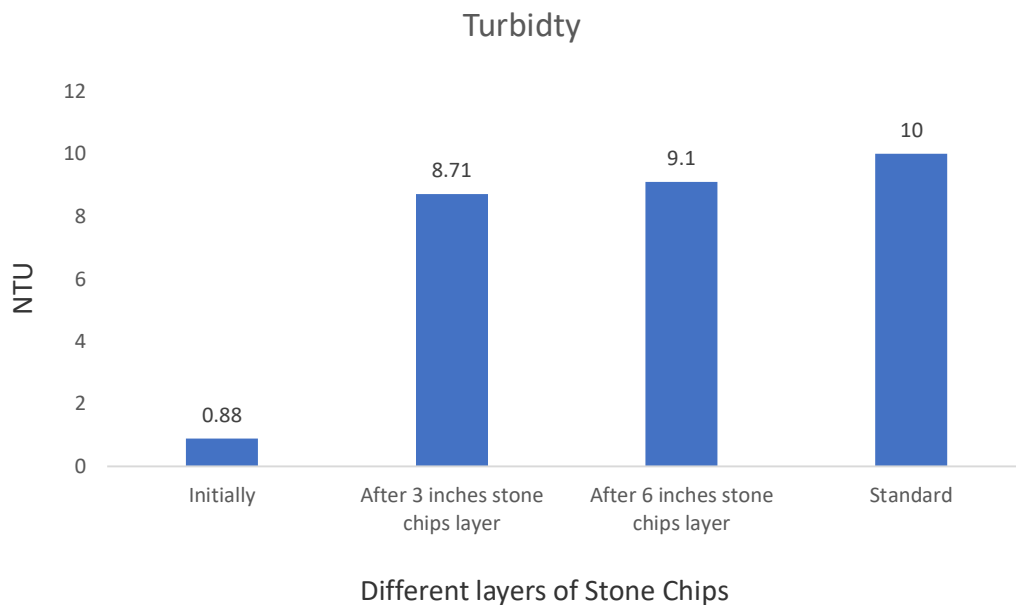
Turbidity :

Initially turbidity of sample water was so low which is 0.88 NTU. After passing from 3 and 6 inches of stone chips layers the turbidity value became much higher. Which are 8.71 NTU for 3 inches and

9.1 NTU for 6 inches. It indicates that there is less amount of microplastics present after passing through the filters.

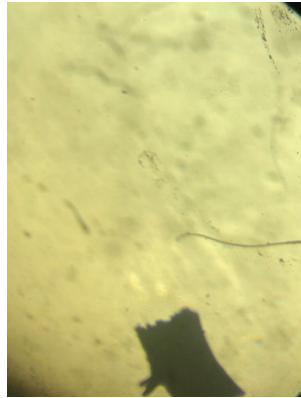
Figure 10: Microscopic view of MP Initial and after filtering(Stone Chips) the sample

Initial Sample

After passing from 6 inches layers
of stone chips

In Figure 10, the microscopic examination photo is given before and after the filtering of the sample. From the microscopic examination photo, it is observed that there are black dot rounded circles and sticky lines which are MP. But in the second microscopic examination photo, the MP was reduced.

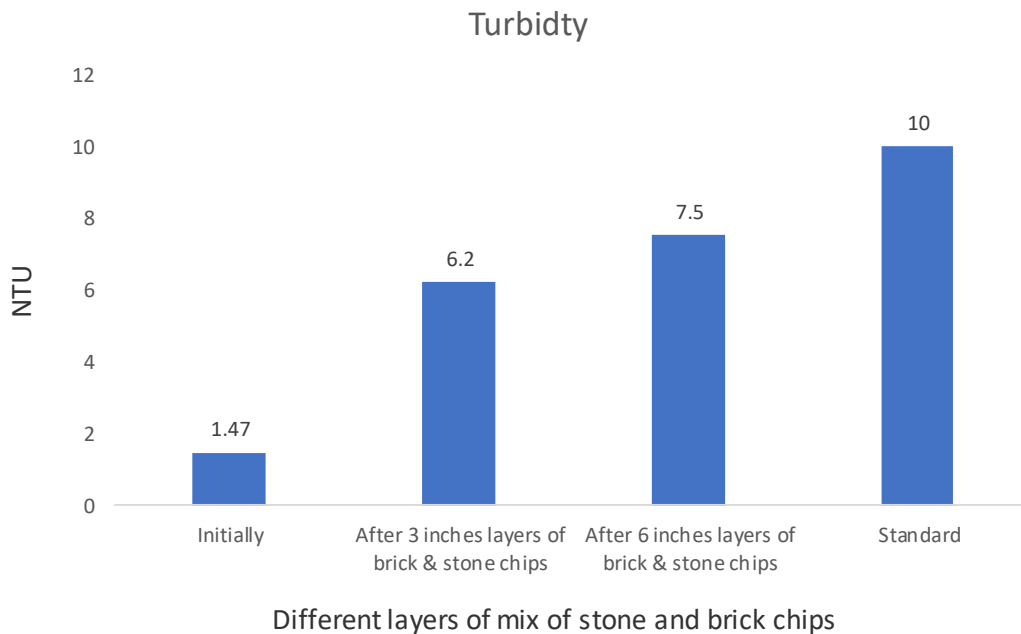
Turbidity :

Initially turbidity of the sample water was so low which is 1.47 NTU. After passing from 3 and 6-inch layers of brick & stone chips, the turbidity value became much higher. Which are 6.2 NTU for 3 inches and 7.5 NTU for 6 inches. It indicates that there is less amount of microplastics present after passing through the filters.
